BINASLAWA MIDDLE SCHOOL

ERBIL, IRAQ

**SIGIR PA-08-121**  
**APRIL 21, 2008**

SUBJECT: Report on Project Assessment of the Binaslawa Middle School, Erbil, Iraq (Report Number SIGIR PA-08-121)

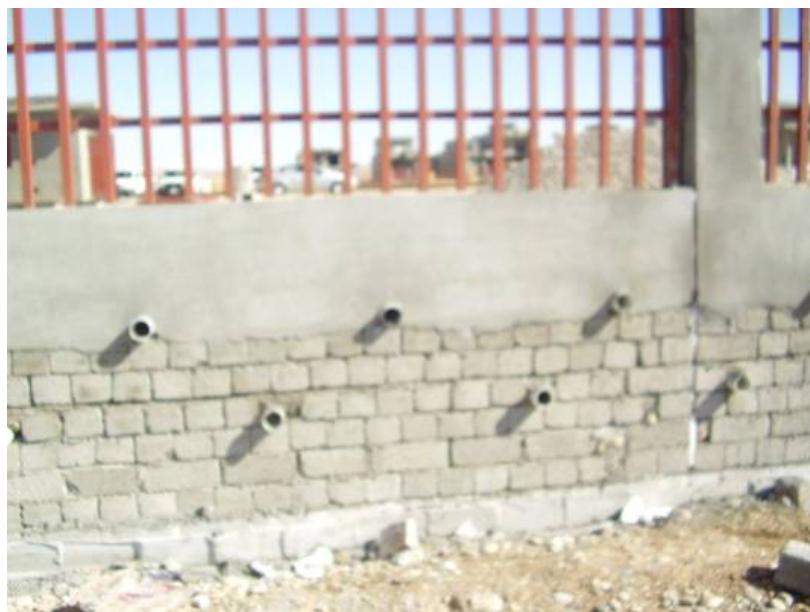
The playground was framed by concrete blocks with two courses above ground. The area had not yet been filled with sand. The grounds were graded and sloping away from the buildings to a location near the perimeter retaining wall through which a number of drain pipes were installed. The workmanship and materials appeared to be adequate. Site Photos 1 and 2 show the grading and drain pipes in the perimeter retaining wall.

**Site Photo 1. Drain pipes in perimeter retaining wall**

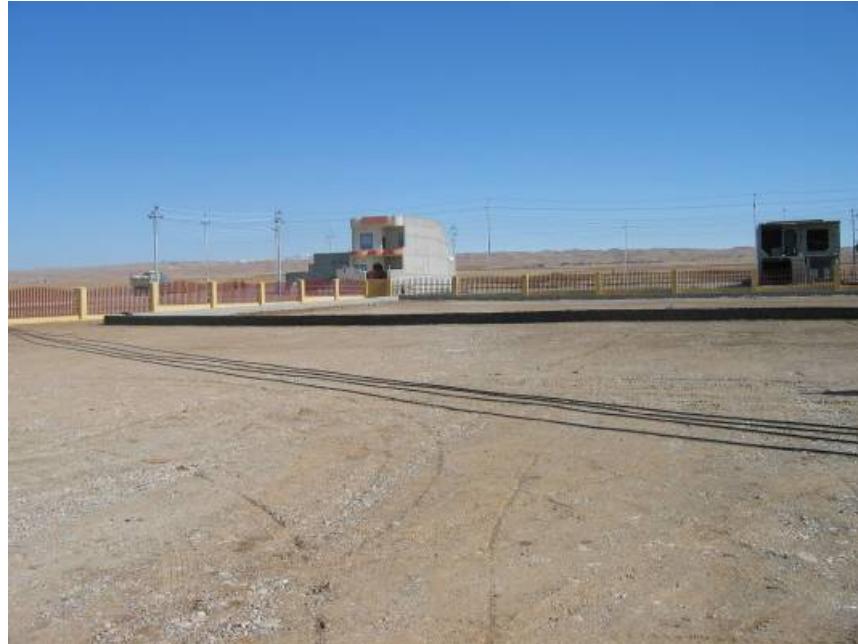
**Site Photo 2. Graded facility grounds**

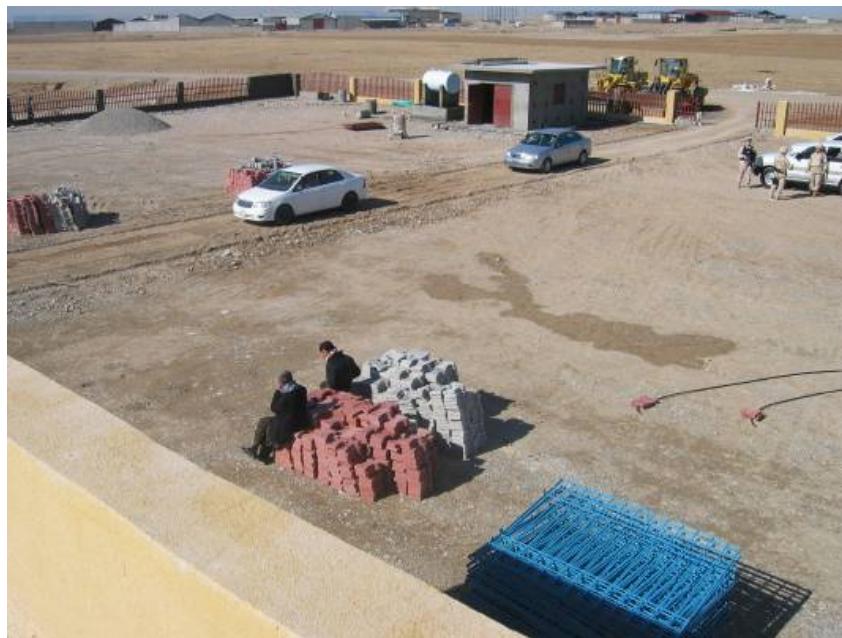
Paving stone will be used to construct walkways and driveways. Some of the driveways were being graded at the time of the inspection but stone laying had not started. Site Photos 3 and 4 show a driveway layout and stacked stone ready for installation.

**Site Photo 3. Driveway being prepared for paving stone installation**

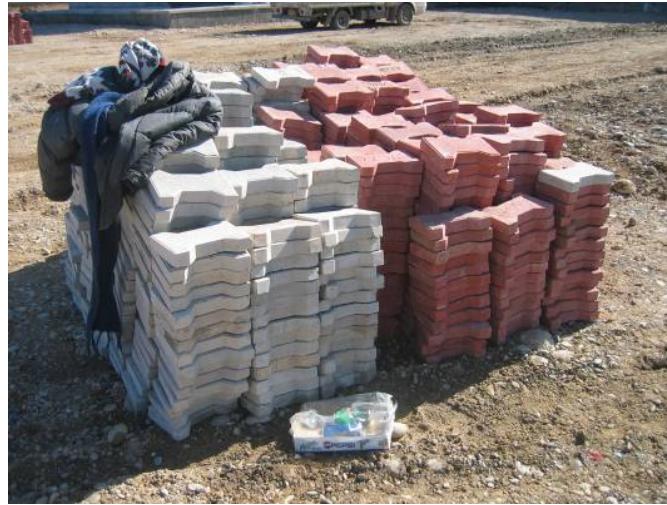
**Site Photo 4. Stacked paving stones**

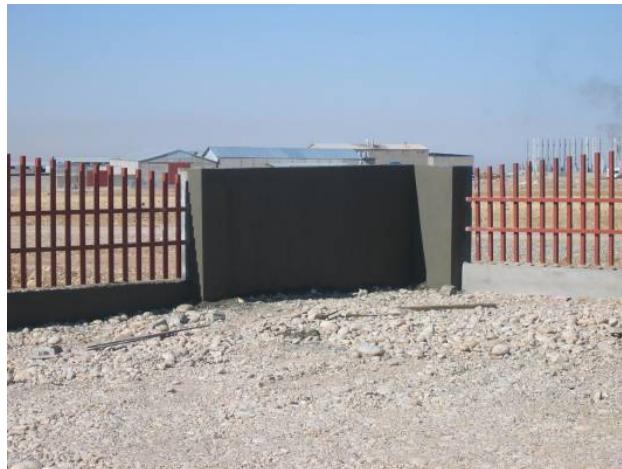
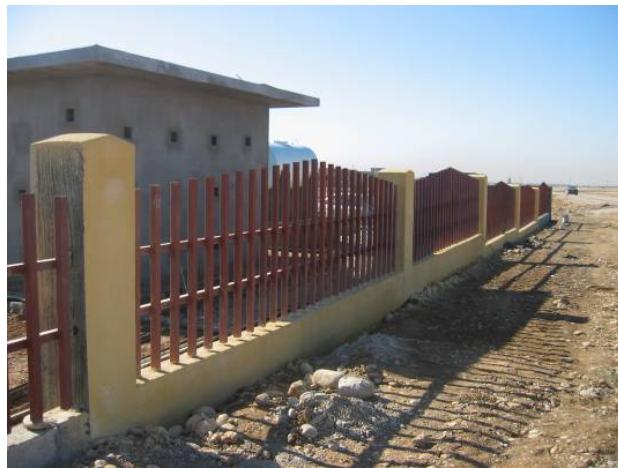
We observed and photographed different segments of the perimeter fence that were installed but not yet painted. The fence is made with a concrete block foundation; pillars spaced approximately 15 feet apart, and connected with vertical steel pipes approximately 2" square. The materials and workmanship appeared adequate. Site Photos 5 and 6 are examples of the perimeter fence.

**Site Photo 5. Corner segment of the perimeter fence**

**Site Photo 6. Perimeter fence segment**

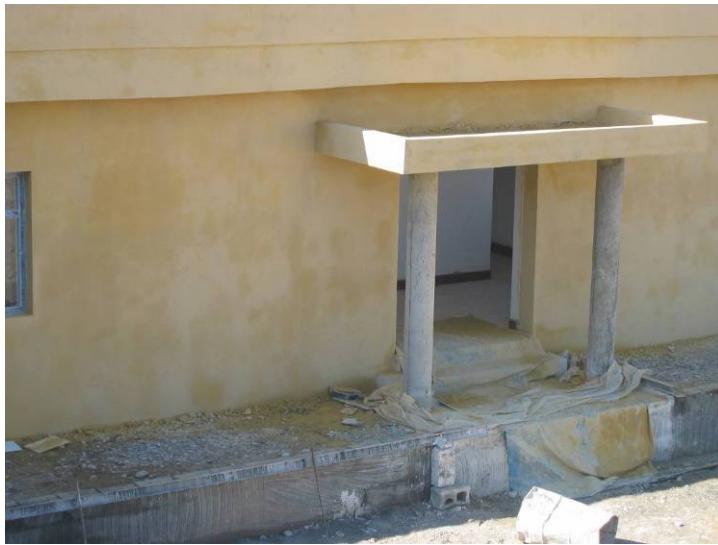
The single-story building was being finished at the time of the visit. Rendering and painting was partially complete and the workmanship and materials for the outside walls appeared adequate.

**Site Photo 7. Outside finish work in progress**

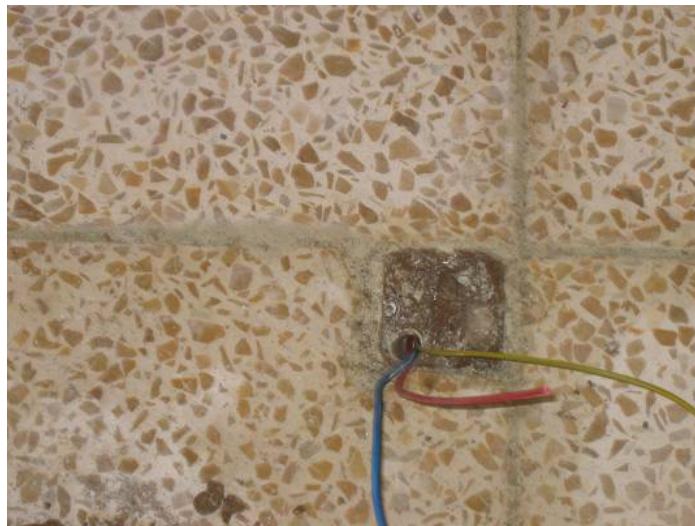
- a. The hallways were complete with adequate floors, walls and lighting
- b. Classrooms floors, walls, and lighting were adequate. Each room had accommodations for two split air conditioning/heating units which were not installed at the time of our visit.
- c. Electrical receptacles were being installed in the computer room floor in about six foot square grids. The receptacles were covered with a clear plastic hinged cover that will protect them from dirt. The quality of the workmanship and materials were adequate. Site Photos 8 and 9 show the wiring through the floor conduit and the covered receptacle.

**Site Photo 8. Electrical wiring routed through conduit in the computer room floor.**

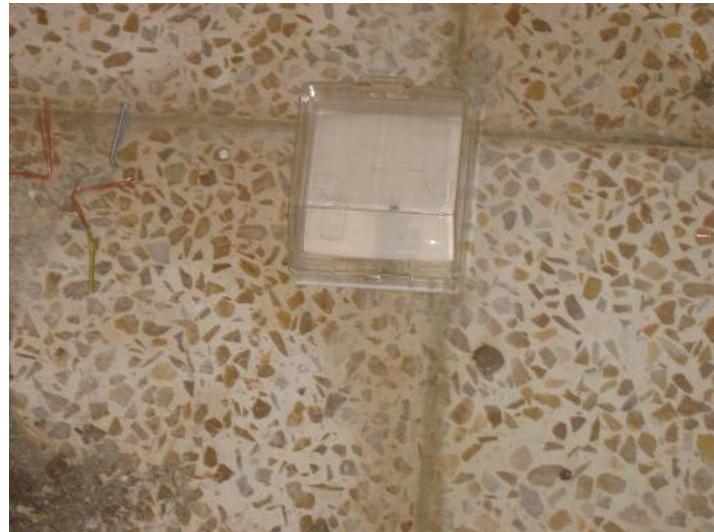
**Site Photo 9.** Covered electrical receptacle installed in the computer room floor

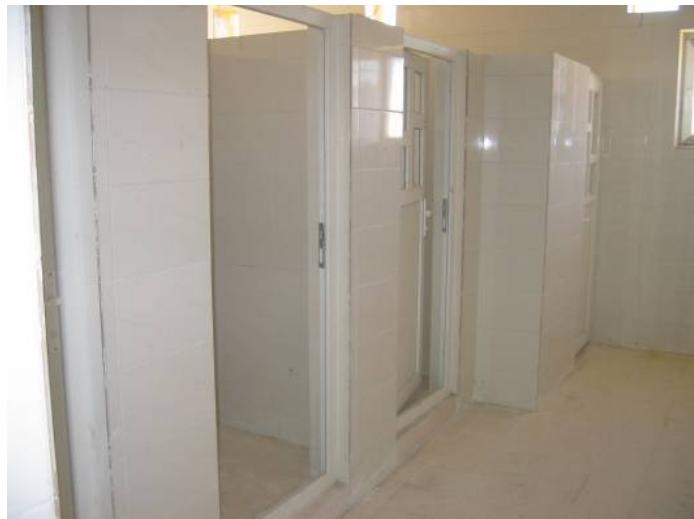
- d. The bathrooms were under construction. The ceilings were about 90 percent complete and the flooring was installed. No sinks or toilet fixtures were installed. Wiring was routed for the ceiling lights which were not installed. The materials and workmanship were adequate. Site Photo 10 shows a partially completed bathroom.

**Site Photo 10.** Bathroom work in progress

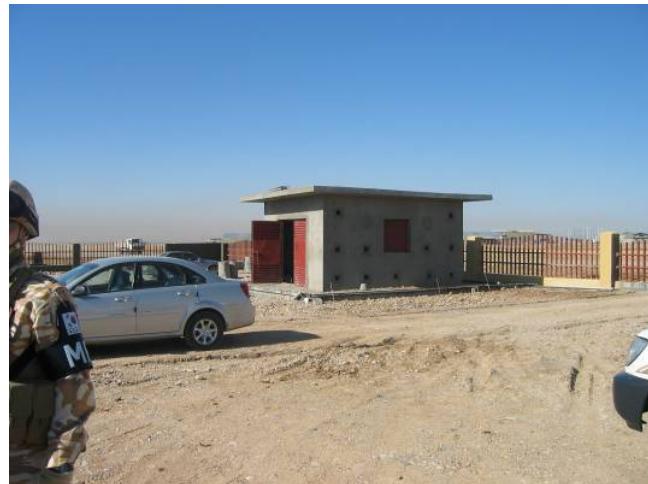
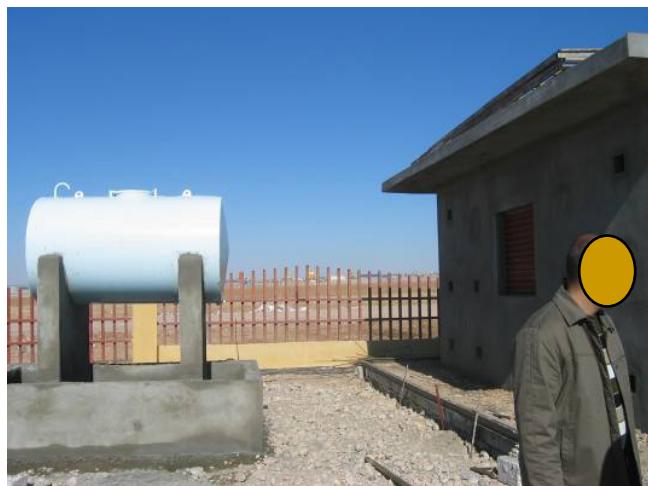
The generator building walls and roof were under construction and the workmanship and materials were adequate. The generator floor was not yet laid and the generator was not installed. The contractor confirmed that the generator exhaust will be routed outside the building. The fuel tank installation was adequate. The fuel line to the generator house was not yet installed. Site Photos 11 and 12 show the generator house and fuel tank.

Site Photo 11. Generator house work in progress

Site Photo 12. Generator fuel tank work in progress

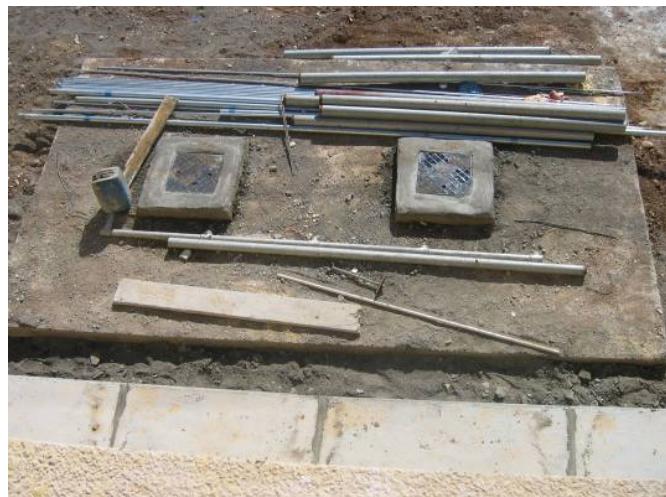
**Site Photo 13. Septic tank covers**

The area where the septic tanks and cesspool are located is not secured to prevent access by school children and poses a health and safety hazard.

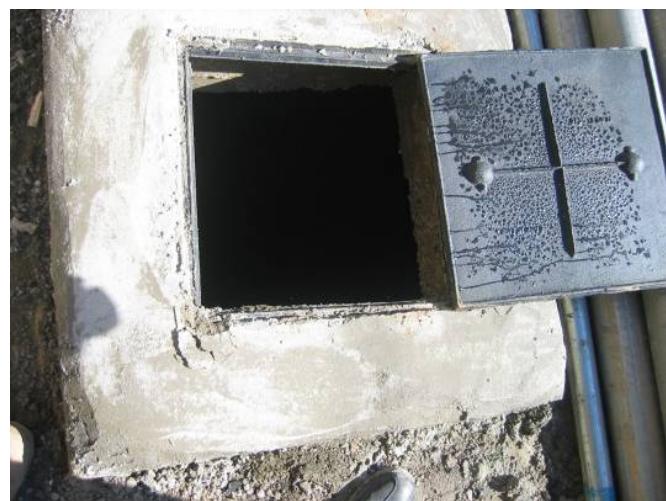
**Site Photo 14. Cesspool cover**
